Frequent Moisture Retare Messages

Problem Description: Receiving retare messages because of moisture readings moving outside the retare margin (i.e. above 1%).

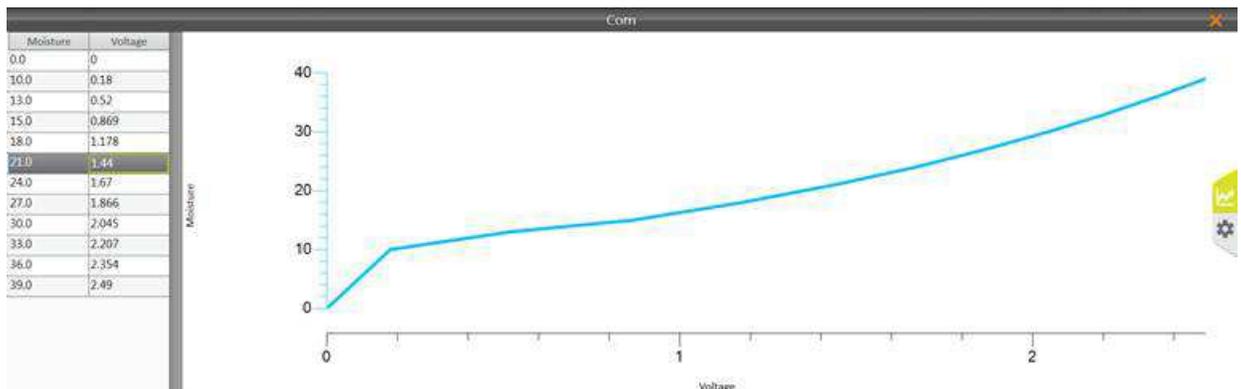
1. Some trash or debris may be caught on the blade. Operators should always verify that the moisture blade is clean and free of any debris.
2. The moisture curve calibration may not be accurate between 0 and the lowest point (as shown below). This phenomenon can occur with both Mirus and FRS.

In the example above, the moisture voltage only needs to change by .02 volts to product 1%. Obviously the moisture is not accurate below 10% and is causing the moisture to fluctuate with an empty bucket (i.e. noise level).
