BDS Cup door adjustment

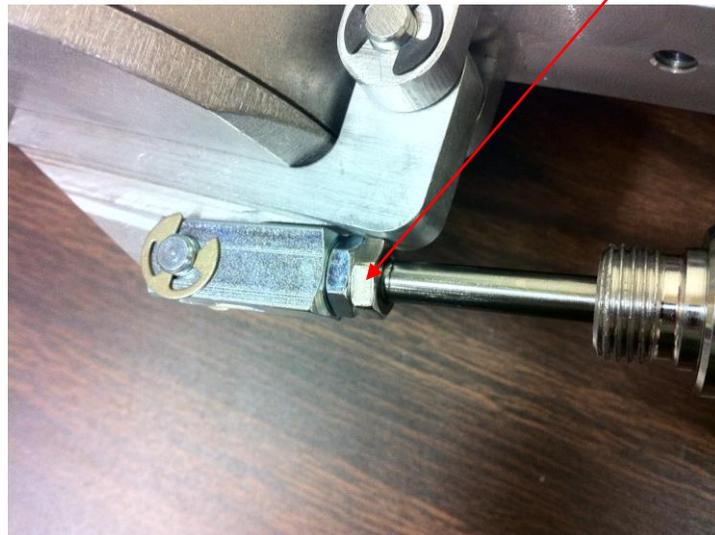
- To prevent the BDS cup door from striking the moisture sensor trash deflector when the moisture has been moved below the cup, the cup door may need to be adjusted.
- First check the cup door to determine if it has enough clearance so that it does not touch the trash deflector.
- If the cup door does not clear the trash deflector, follow the steps outlined to adjusting the cup door.
- Remove the Piston Rod Clevis, tighten the nut behind the Clevis all the way onto the actuator rod. Add a ½ - 28 nut PN 22883 onto the Piston Rod. If the clevis does not already have a nut on the end of the actuator rod, add a second ½ - 28 nut.
- Apply Loctite 248 to threads of the air cylinder rod and insert into clevis.
- Insert the pin that come with the Piston Rod Clevis Kit through the cylinder clevis and hinge bracket.
- Place the e-style retaining ring on the pin.
- Test cup door clearance

½ -28 Nut
PN 22883
